## INVENTORY FORM FOR STATE HISTORIC SITES SURVEY

15 Linden Terrace

Towson

BA-2156

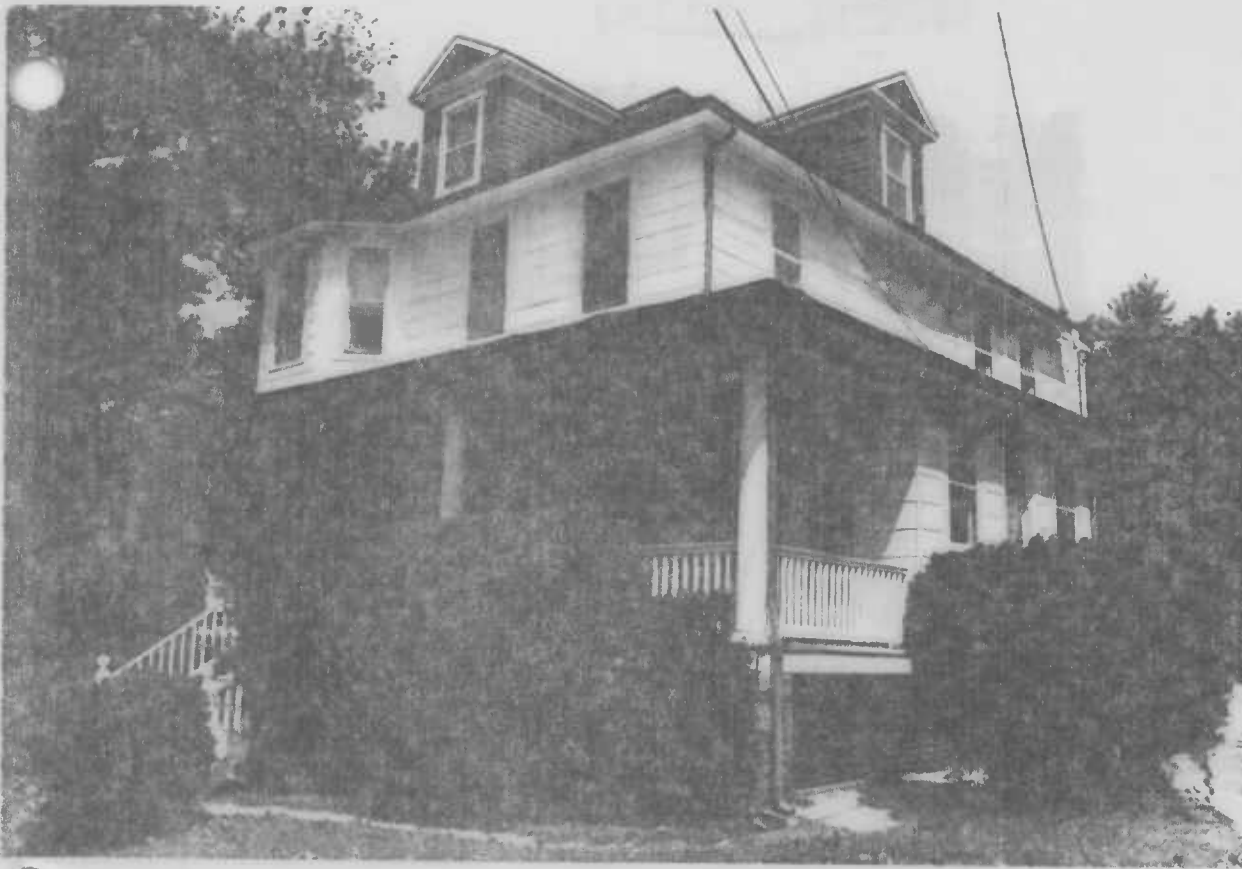
ABOVE: South-east Corner

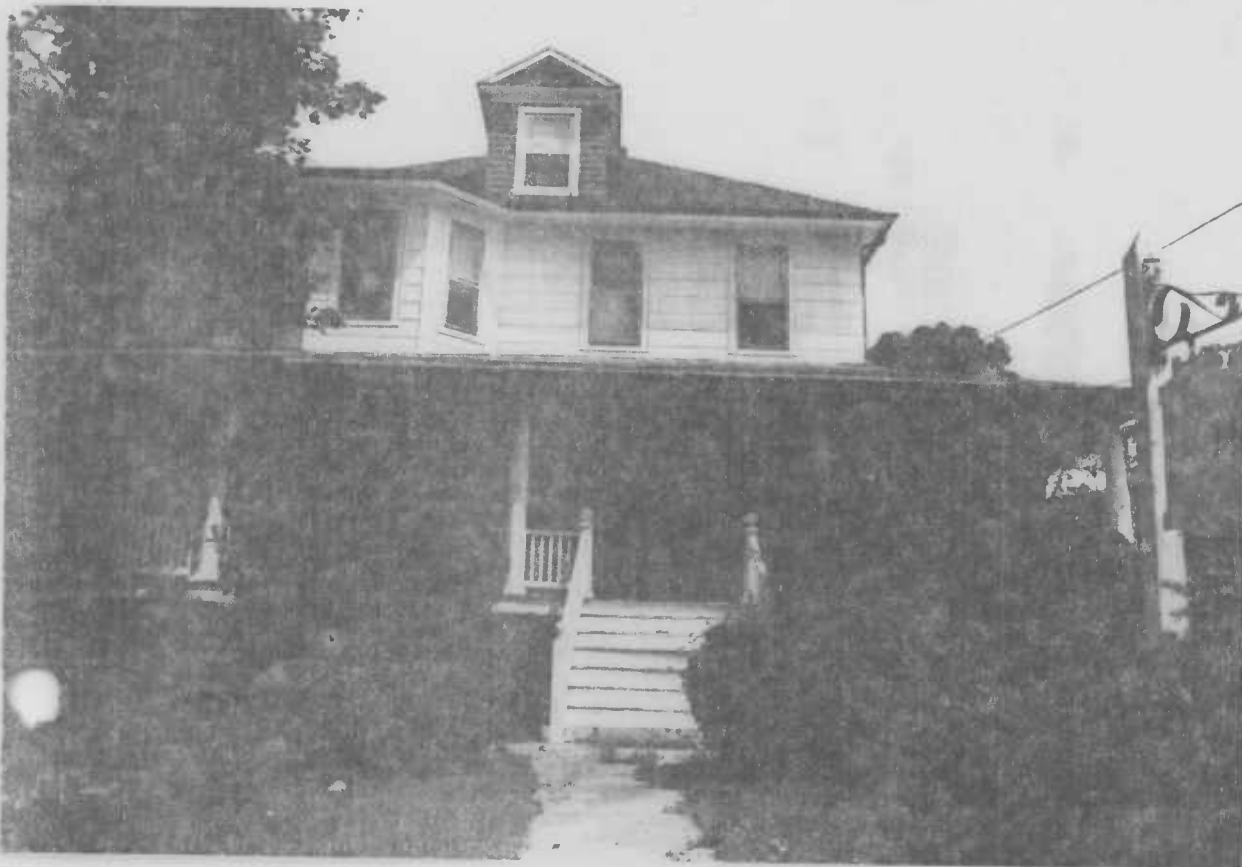
The house faces south on Linden Terrace and the main facade is three bays wide. Six wood steps lead to the front porch which is floored with tongue and groove floorboards and is supported by four Doric wood columns resting on stone porch piers. A hand-rail with plain balusters and newel post appear on each side of the steps. The section of porch spanning the main facade is surrounded by a plain balustraded railing and is covered with a tongue and groove ceiling. Where the porch reaches the end of the main facade, it turns the corners and covers half of the west and east facades respectively. These two sections of the porch are enclosed with white asbestos shingles. Casement windows appear in the north facade of the enclosed western section while glass double doors are found on the eastern part.

The formal entrance which is located slightly off center consists of an interior door with an upper rectangular panel of glass and a lower inset panel of wood. Sidelights flank the door and a five light transom hangs above. To the right of the entrance is a 1/1 double hung sash window, and to the left is a two-story bay window comprised of six 1/1 sash windows. The second floor on the main facade has two 1/1 sash windows in addition to the second story bay window. A pedimented gable dormer with a 1/1 sash window appears on the attic floor.

BELOW: South (Main) Facade

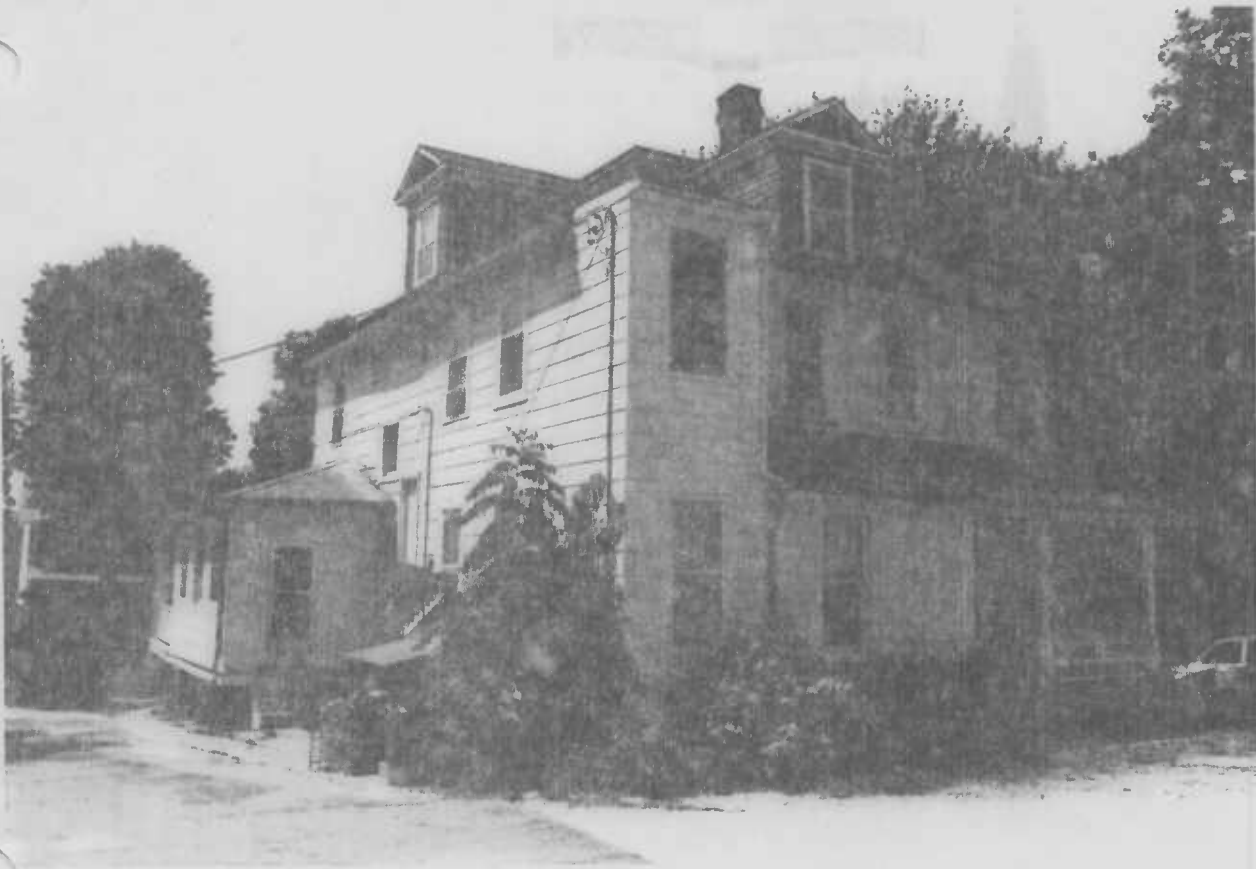
The east facade contains three 1/1 sash windows in the enclosed porch as well as a glass and wood paneled door opening into the porch. Additional fenestration on this side of the house includes two 1/1 sash windows on the first floor and three on the second floor. A small stained glass window appears between the first and second floors (possibly located on the landing of an interior flight of stairs). Slightly below this stained glass window and approximately seven feet from the ground a door

has been cut into the side of the wall. No steps lead to the door and it appears not to be in use at the present time. Presumably when the house was divided into apartments, this door was added to accomodate the change. A bulkhead cellar entrance and a pedimented gable dormer appear on this east facade as well.

ABOVE: North-east Facade

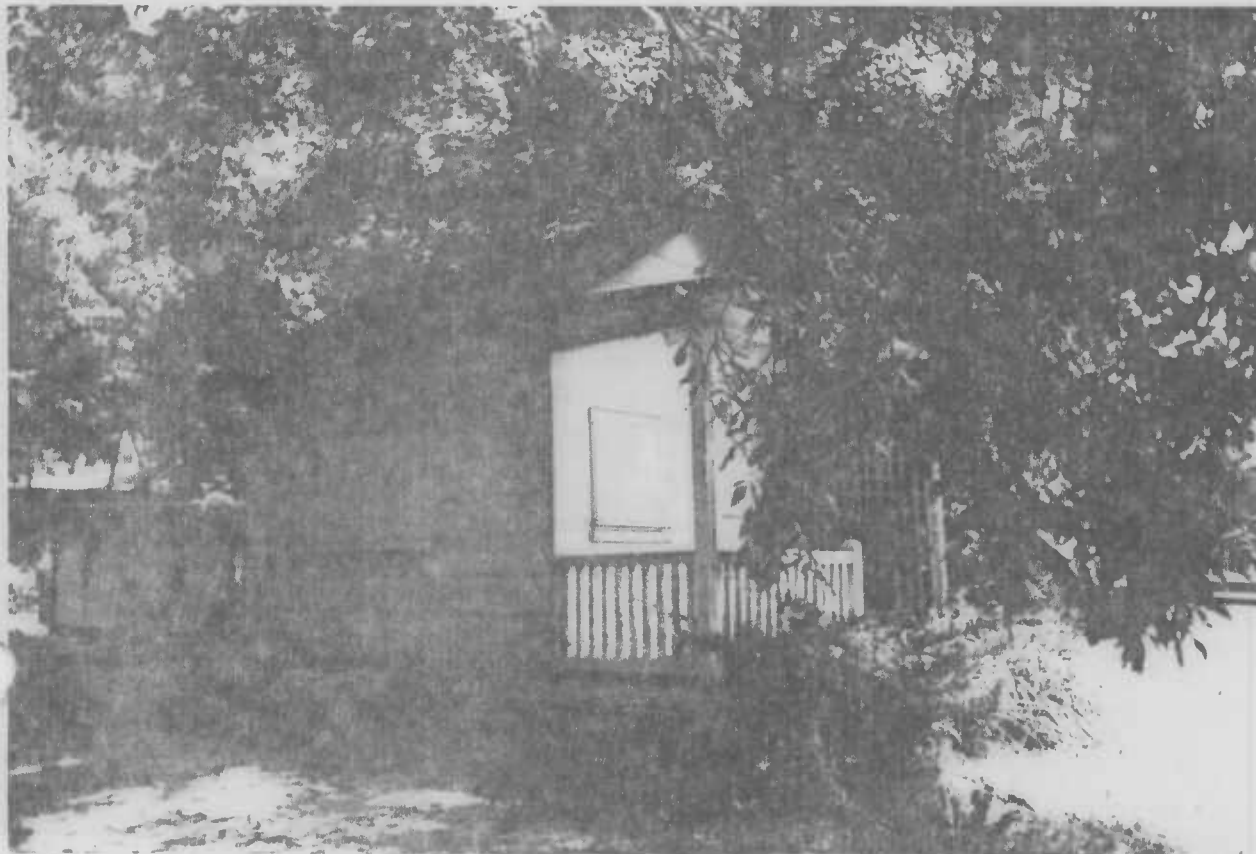
Fenestration on the south facade consists of four 1/1 sash windows on the second floor and four on the first floor. A wood door leads through the enclosed section of the porch to one apartment and a second door on the open section of the porch leads to a second apartment. Once again a pedimented gable dormer with a 1/1 sash window appears on the attic floor.

The west facade like the north facade is three bays wide and contains a two story bay window comprised of six 1/1 sash windows. The enclosed porch extends half way around the west facade and contains ten screened panels. Two 1/1 sash windows appear on the second floor above the porch. A screened cellar window has been cut into the foundation under the bay window. The pedimented gable dormer is symmetrically placed on the hip roof.

BELOW: South-west Facade
